# Manhole Inspection Summary

Manhole # S45U\_\_030MH

**Location** Address: **1200 Towson Street**

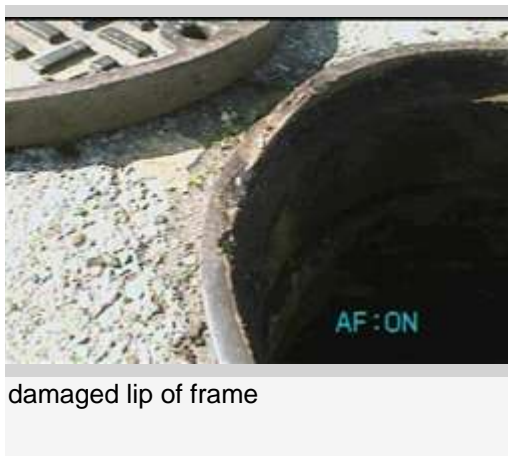
Defect 4

Condition: ☐ Sound ☒ **Cracked** ☐ Leaks

damaged lip of frame

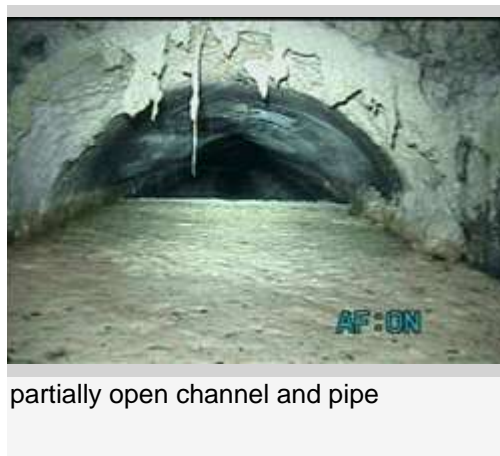
Defect 3

Channel Exposure: **Partially Open** Junc Dist: **0** nearest .5 ft. Azimuth: **0**

Condition: ☐ Sound ☐ Cracked ☐ Root Intrusion ☐ Deteriorated ☐ Leaks ☒ **Debris**

partially open channel and pipe

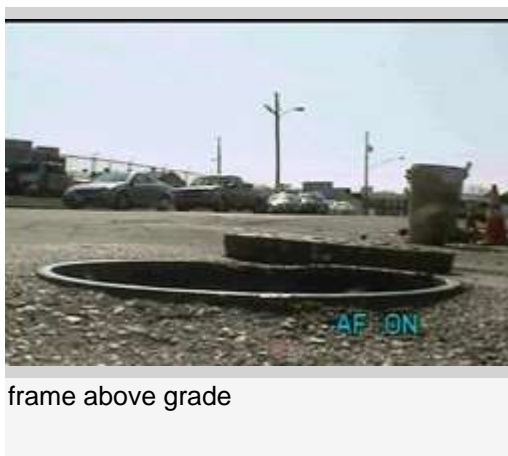
Defect 1

Diameter: **26** (in.) Length: **0** (in.) Dist A/B Grade: **1** (in.)

frame above grade

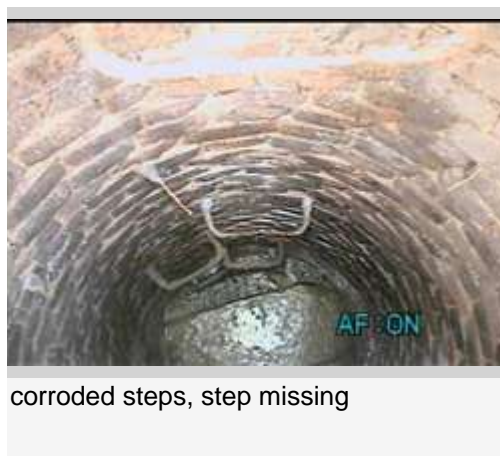
Count: **7** Missing: **1** ☒ **Corroded**

corroded steps, step missing

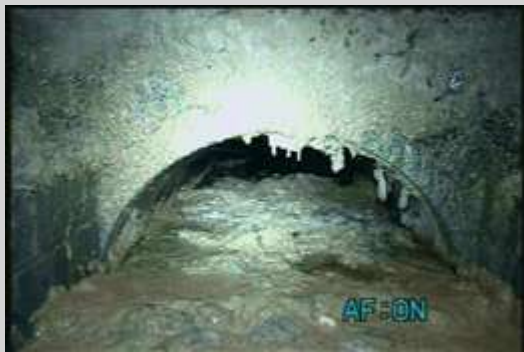
12 O'Clock Outflow

24 in. Circular Gravity Sewer  
Pipe Out @ 12 O'Clock

Deposits: ☐ None ☐ Mud ☒ **Sludge** ☐ Debris ☐ Grease

Silt Depth: **16** (in.) Deposits Extent: **Heavy**

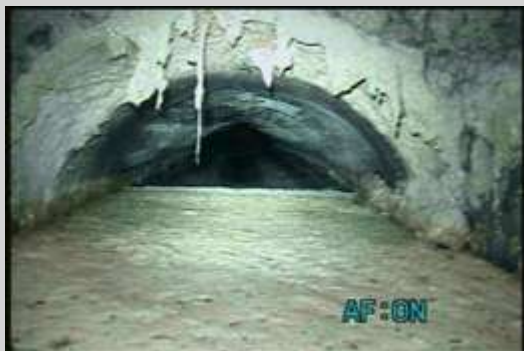
6 O'Clock Inflow

24 in. Circular Gravity Sewer  
Pipe In @ 6 O'Clock

Deposits: ☐ None ☐ Mud ☒ **Sludge** ☐ Debris ☐ Grease

Silt Depth: **14** (in.) Deposits Extent: **Heavy**

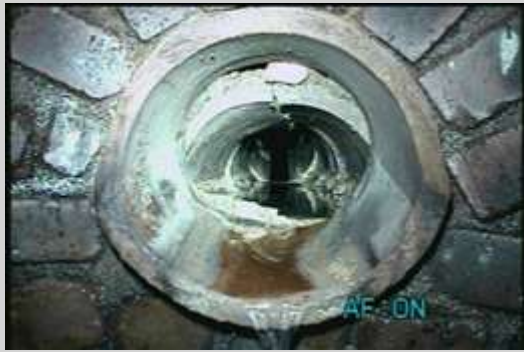
Pipe In @ 9 OClock

8 in. Circular Gravity Sewer

Infiltration: **Dripper** Pipe Seal Cond: **Broken**

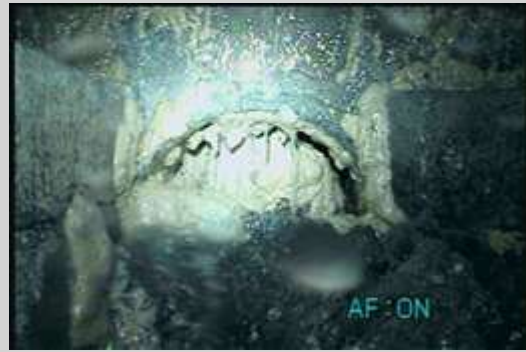
Drop In @ 9 OClock

Drop: **Outside Direct**

Drop Condition: **Clogged**
